**UNIT 1 - SPRING, 1989, OUTAGE
ENGINEERING INSPECTION REPORT**

STEAM GENERATOR - BURNER INSPECTION

OBSERVATIONS AND WORK ACCOMPLISHED

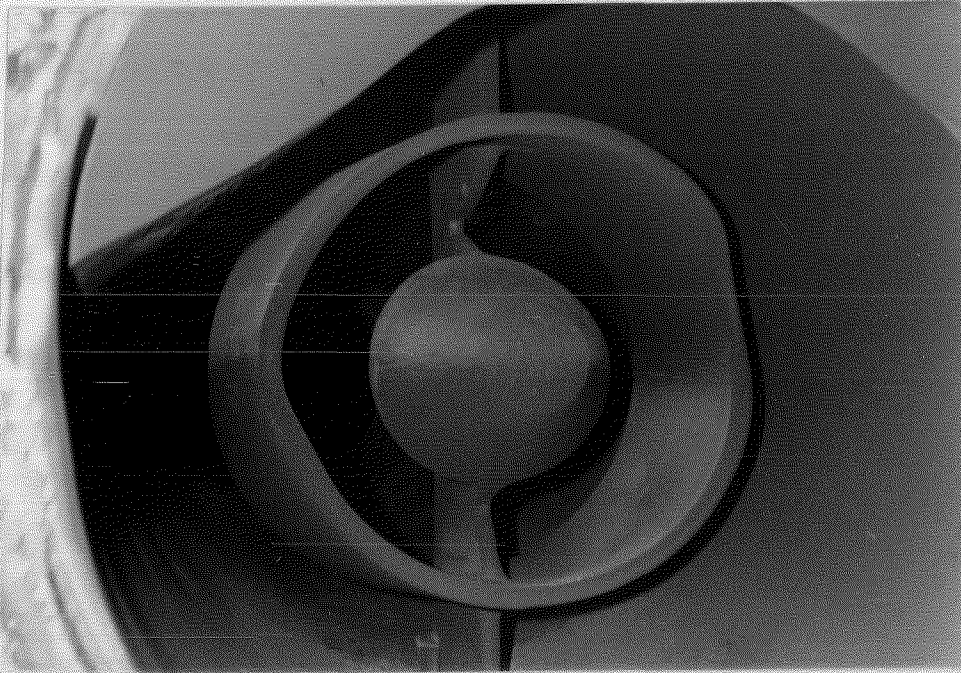
Extensive wear was found on several of the upper vertical struts which hold the conical diffuser to the outer shroud assembly. Burners 1A04 and 1A06 were the worst and had their diffuser assemblies replaced (reference Photos 1 through 3). Wear greater than 50% through the bracket was recommended for replacement. Dimensions were 3 1/2 and 4 1/2 inches respectively of metal remaining on the upper struts as compared to 8 1/2 inches when diffuser assembly is new (see Photo 4).

Photo 1 - Coal Burner 1A04's conical coal diffuser showing extreme wear on upper vertical strut above the cone. Diffuser was replaced.

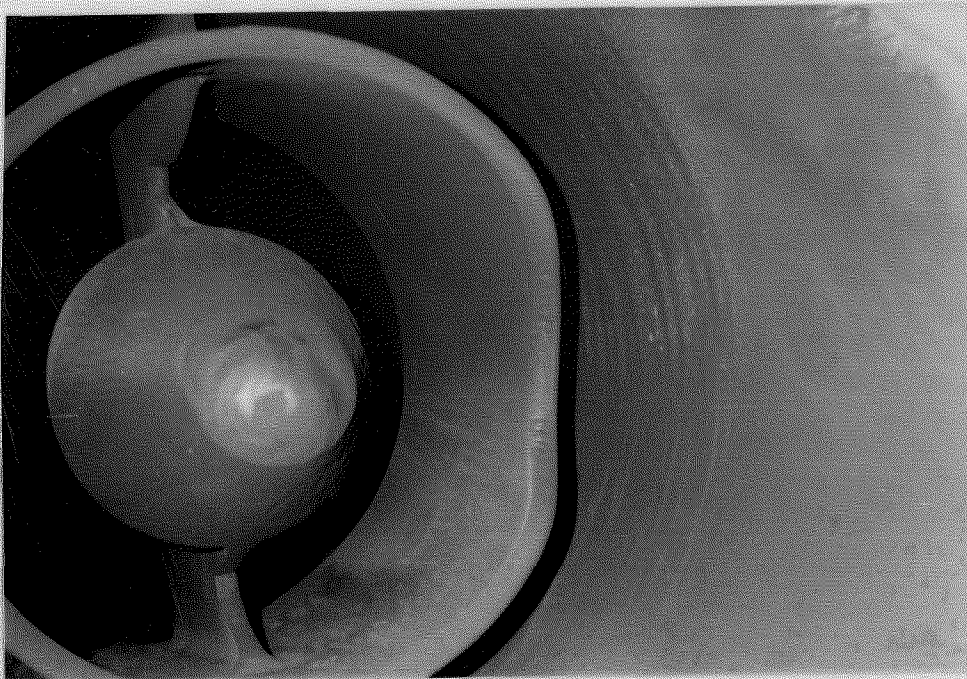
Photo 2 - Conical diffuser for Burner 1A06 showing excessive wear on the upper vertical strut. This diffuser was also replaced.

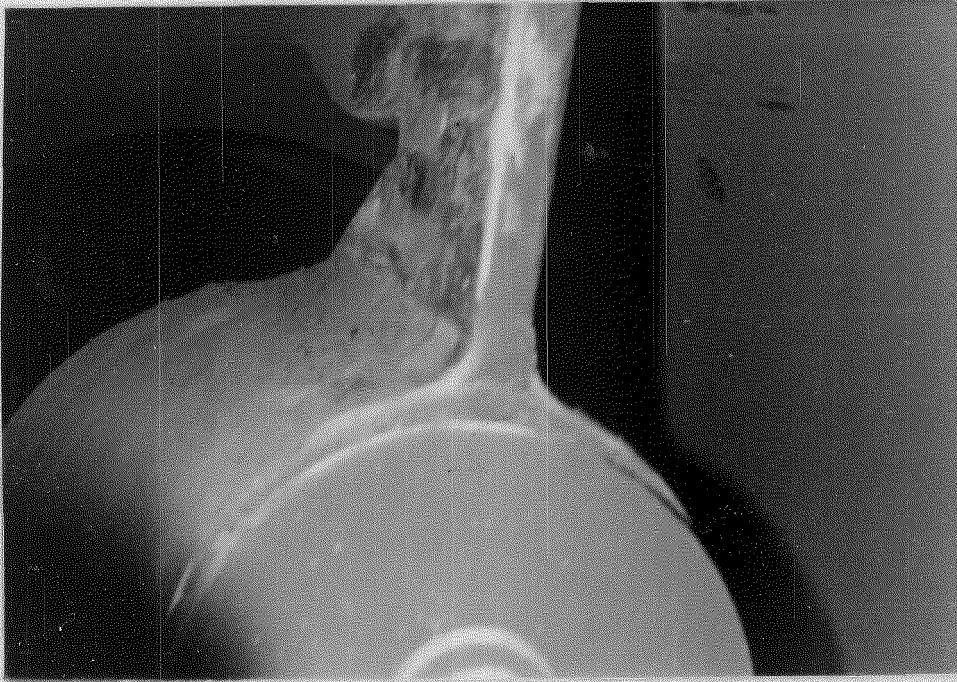
Photo 3 - Backside view of the conical diffuser for Burner 1A06 showing vertical bracket wear. Picture was taken during furnace side inspection from the boiler platform.

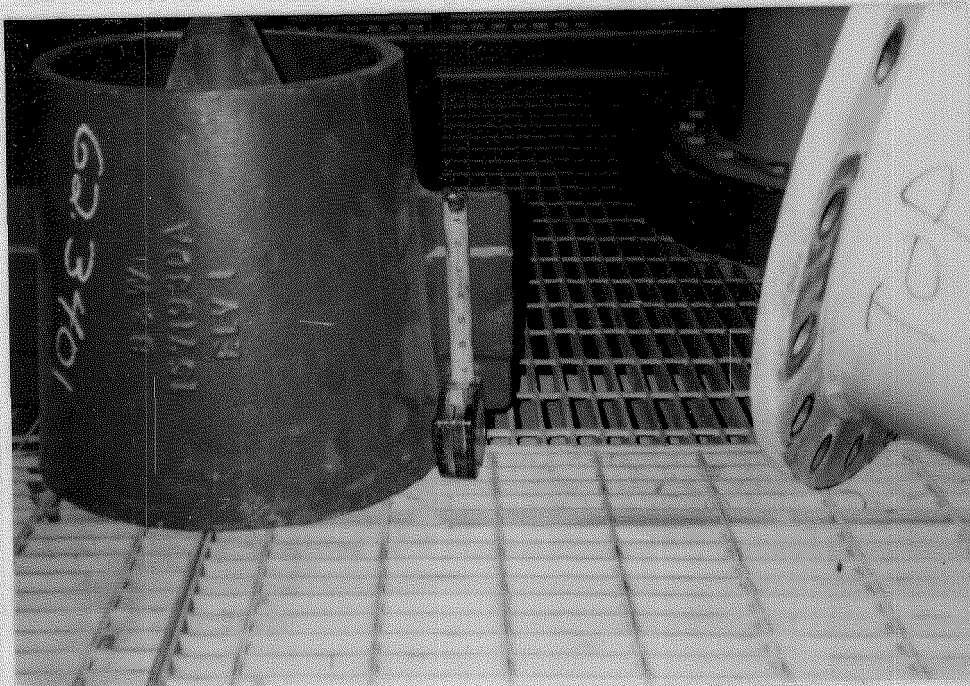
Photo 4 - New conical diffuser prior to installation during

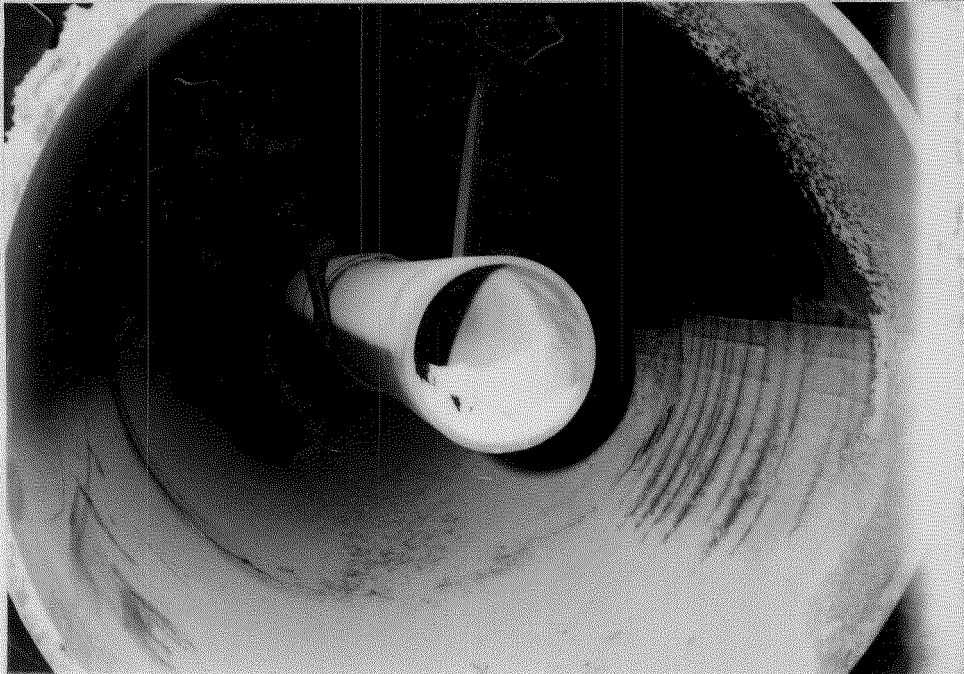
Inspections conducted on the bottom row burners showed extreme signs of wear to the plasma torch sleeves, PT - style diffusers and U-bracket end supports. Reference Photos 5 through 10. B&W did repair the U-bracket supports which hold the end of the plasma torch sleeve to the outer end of the nozzle. In most cases, the U-bracket supports were worn so severe that only 1/2 to 1/8 inch of metal was remaining, plus on two of the twelve burners, the brackets were completely missing. B&W did not repair nor replace the plasma torch sleeves or diffusers.

Photo 5 - Plasma torch ceramic lined sleeve installation on lower row burners with end pluggage (typical), as viewed from furnace.

It was determined by B&W that these items were routine wear and replacement parts should be replaced as required by IPSC during the next available maintenance outage. These alterations pertain to Unit 1 Burner Rows 1B and 1G only.

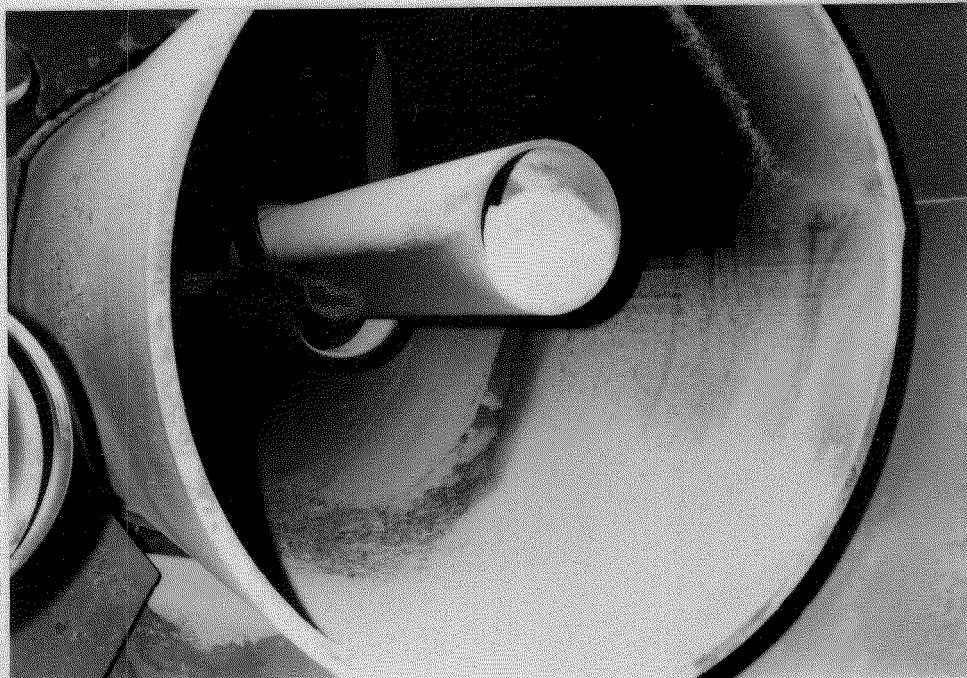
Photo 6 - Misaligned plasma torch sleeve not resting on U-bracket support at burner nozzle tip.

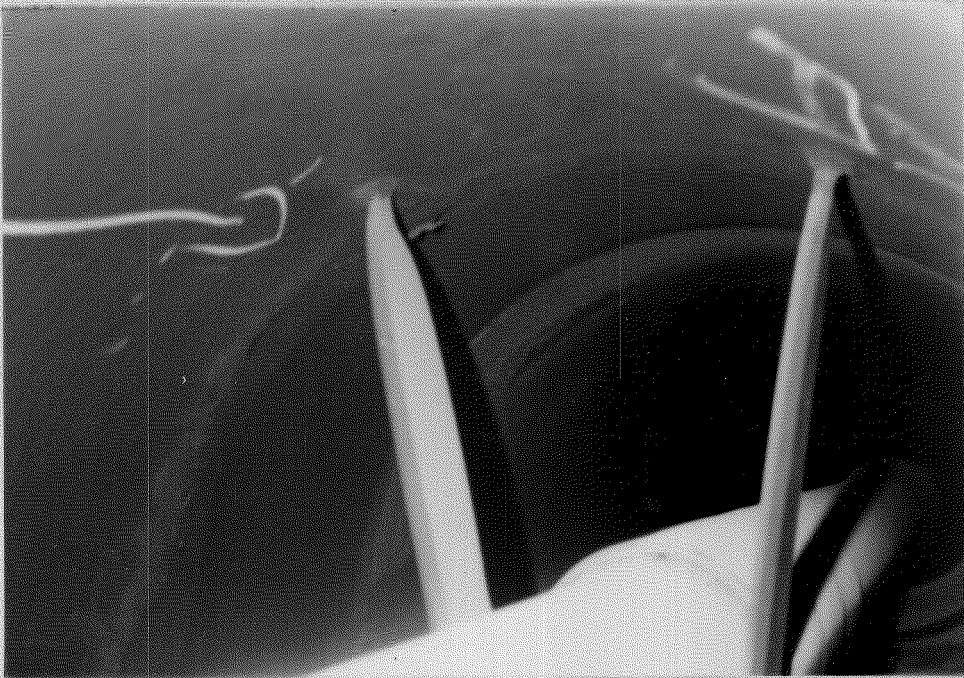
Photo 7 - Plasma torch sleeve U-bracket support showing concentrated erosion against outer wall of burner nozzle (typical).

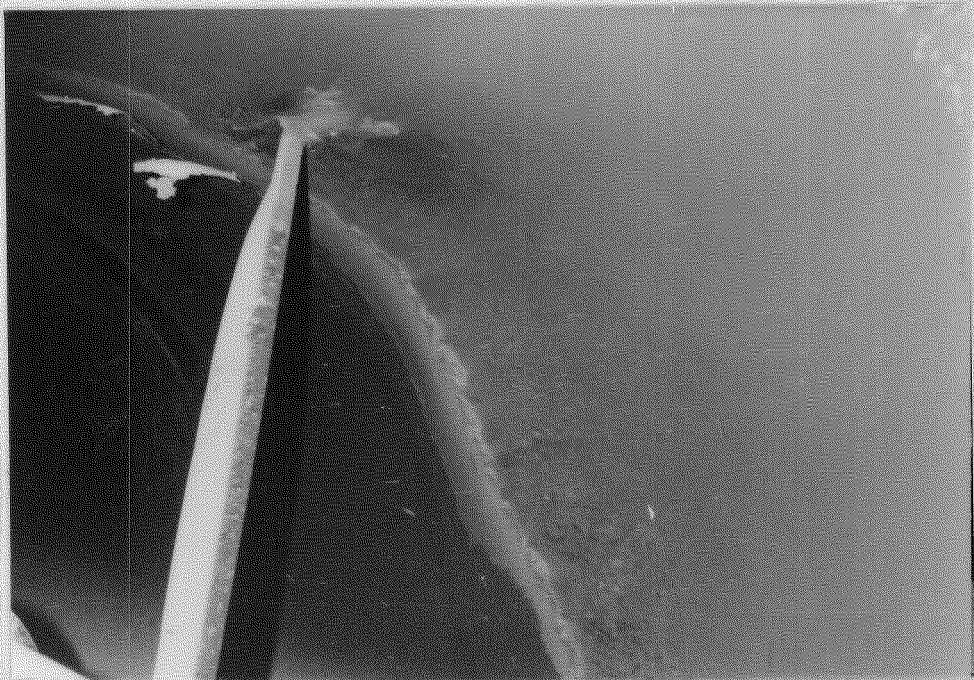
Photo 8 - Extreme wear on the U-bracket support as shown on Burner 1B04. All U-brackets were replaced and repaired.

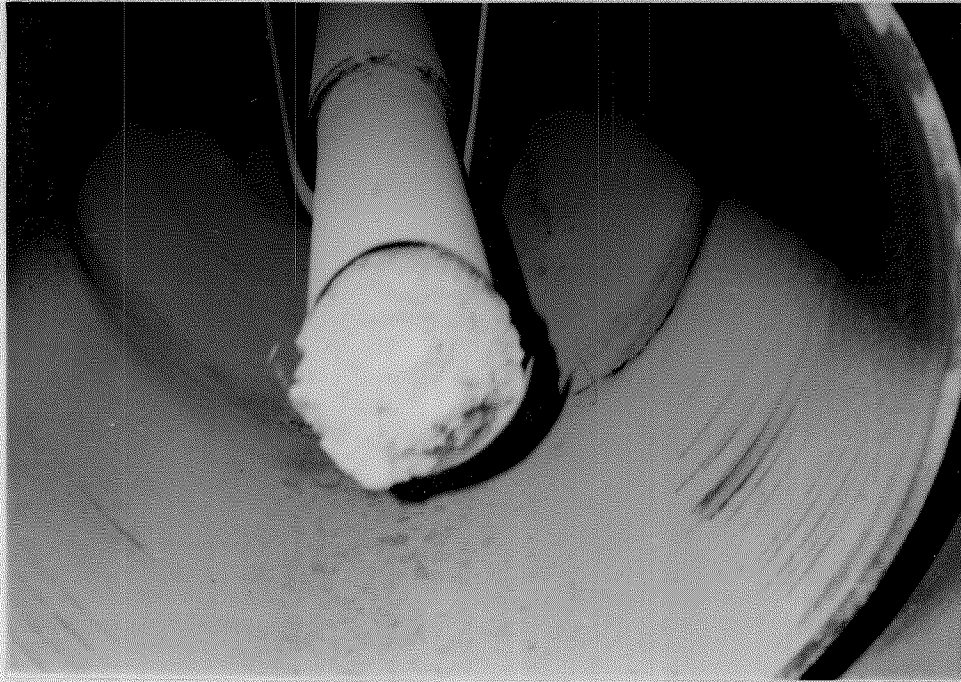
Photo 9 - Severe erosion on the tip of the ceramic plasma torch sleeve on Burner 1B04.

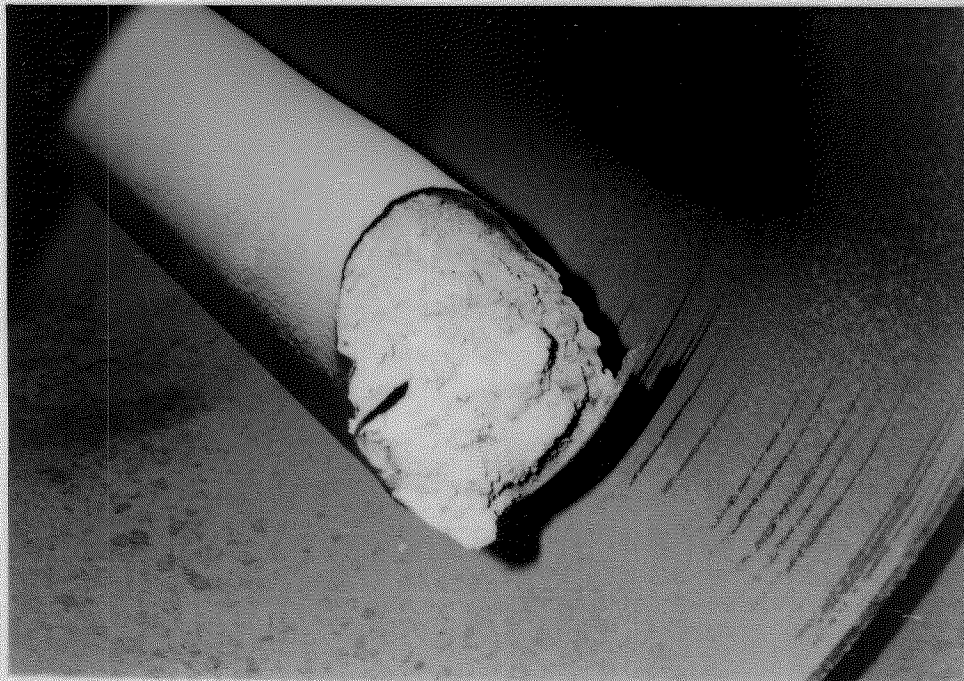
Photo 10 - Another view of Burner 1B04 end tip erosion.

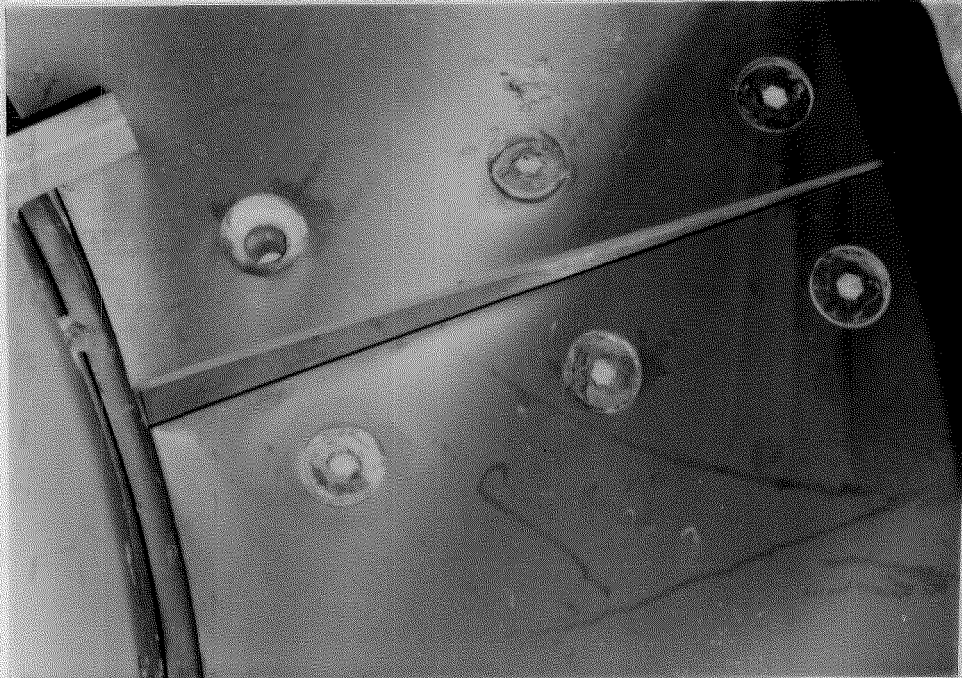
HD OUTER REGISTERS - Photos 11 through 13 show the HD outer register assembly overheat and thermal expansion damage and concerns. The HD outer registers are installed on the upper row burners, Pulverizers 1E (front wall) and 1D (rear wall). These are the only burner rows on either unit which have the modified outer register assemblies installed. The new HD assemblies have an improved style linkage mechanism for the outer register vanes which prevents most of the previous linkage binding.

This overheating condition is occurring although burner front operating and out-of-service temperatures are monitored and maintained below B&W's maximum allowable temperatures (1350 degrees F) for the stainless steel register assemblies.

Photo 11 - HD outer register assembly backplate showing overheating and thermal expansion at bolted joints. Typical of top row burners where HD's are installed.

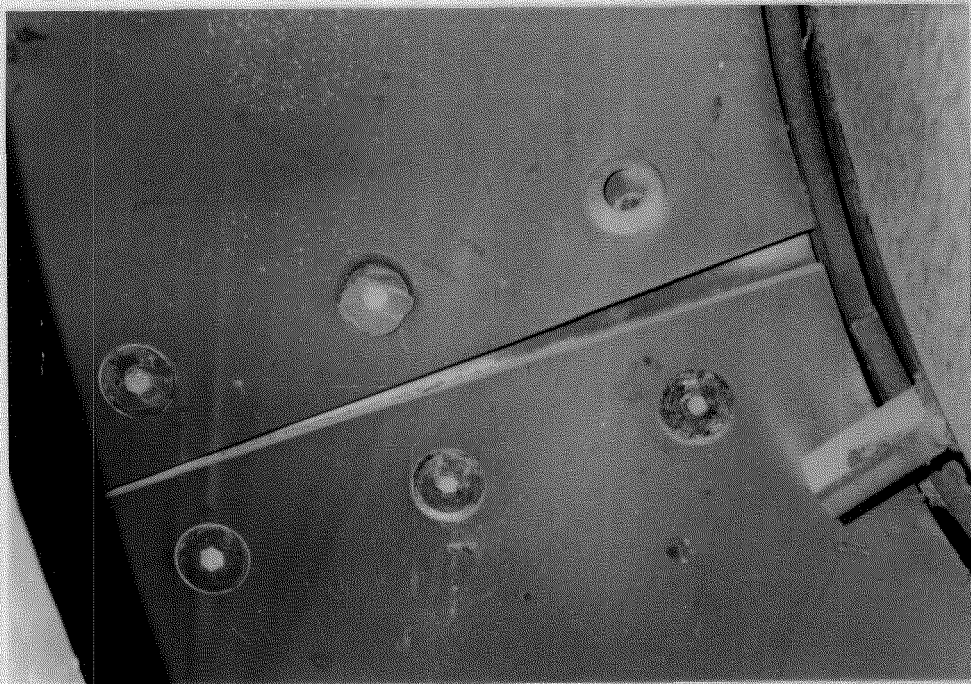
Photo 12 - Overheating and thermal expansion damage to HD outer air register assemblies.

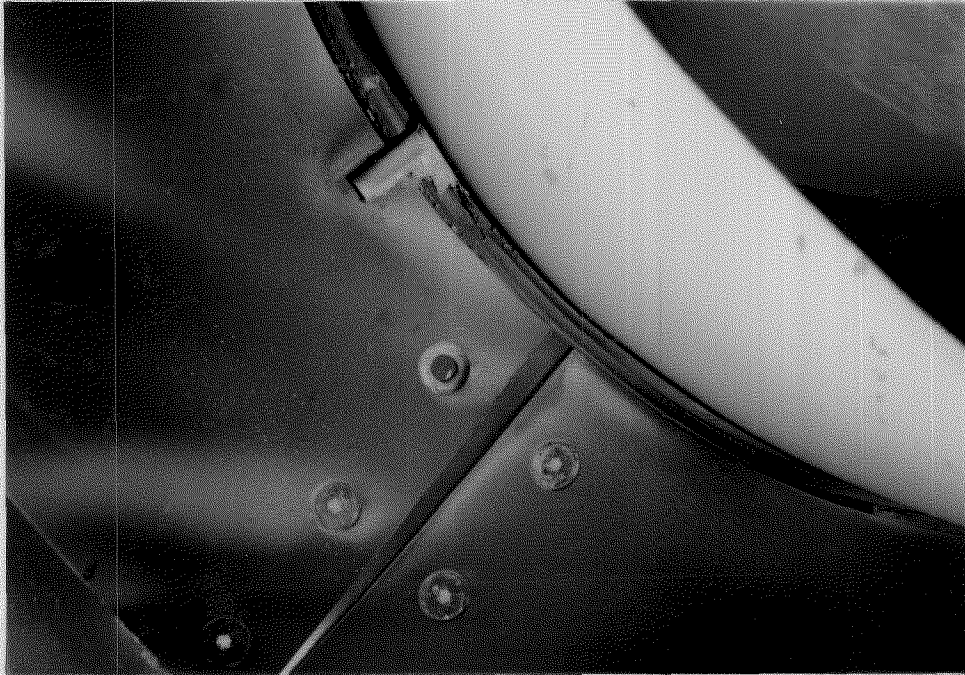
Photo 13 - Another view of a HD outer register assembly with an overheat condition causing permanent expansion damage.

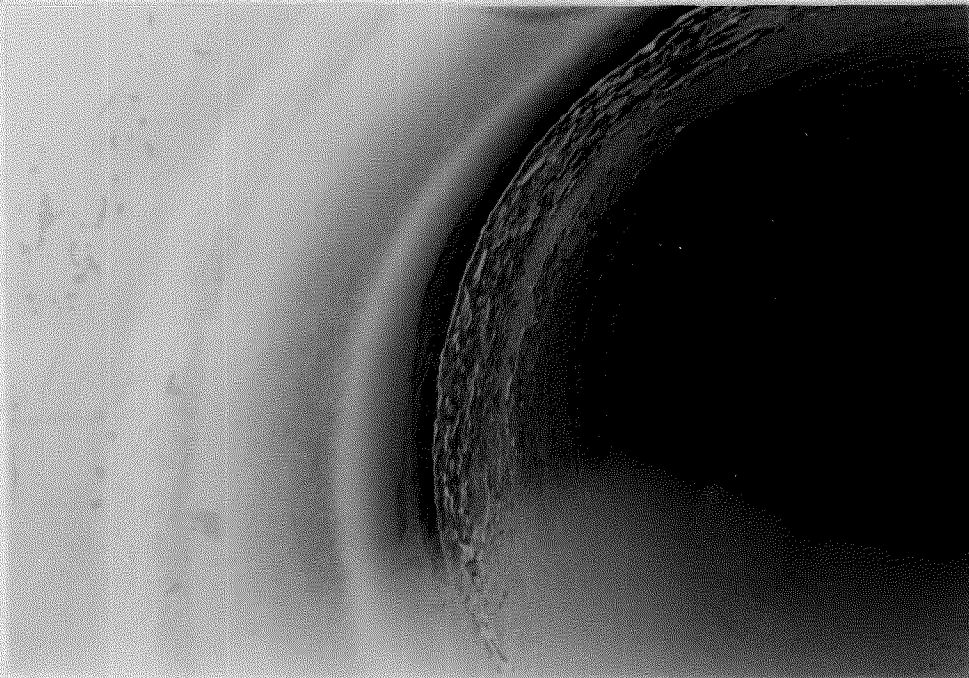
BURNER OVERHEAT - Inspections indicate overheating and thermal expansion is an ongoing problem with the burners and their components which is steadily getting worse. Permanent warping, rippling, barreling, discoloration, flaking and thermal expansion damage is being observed on the HD and standard outer register assemblies, register vanes, drive handles, throat sleeves, inner air sleeves, casing rings, lighter shrouds and lighters (reference Photos 14 through 25 which document these conditions).

Photo 14 - Interior of coal nozzle tip (from furnace side) showing carbon steel portion flaking and the stainless steel tip belling-out or barreling from thermal expansion.

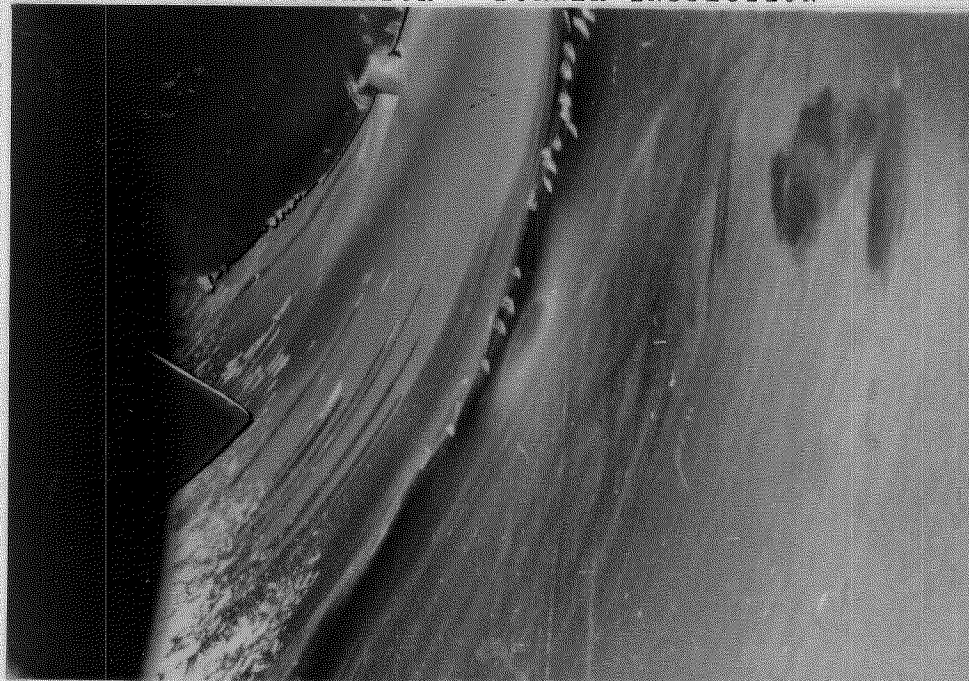
Photo 15 - Inner air sleeve showing overheating and expansion with rippling along seam weld (Burner 1E05).

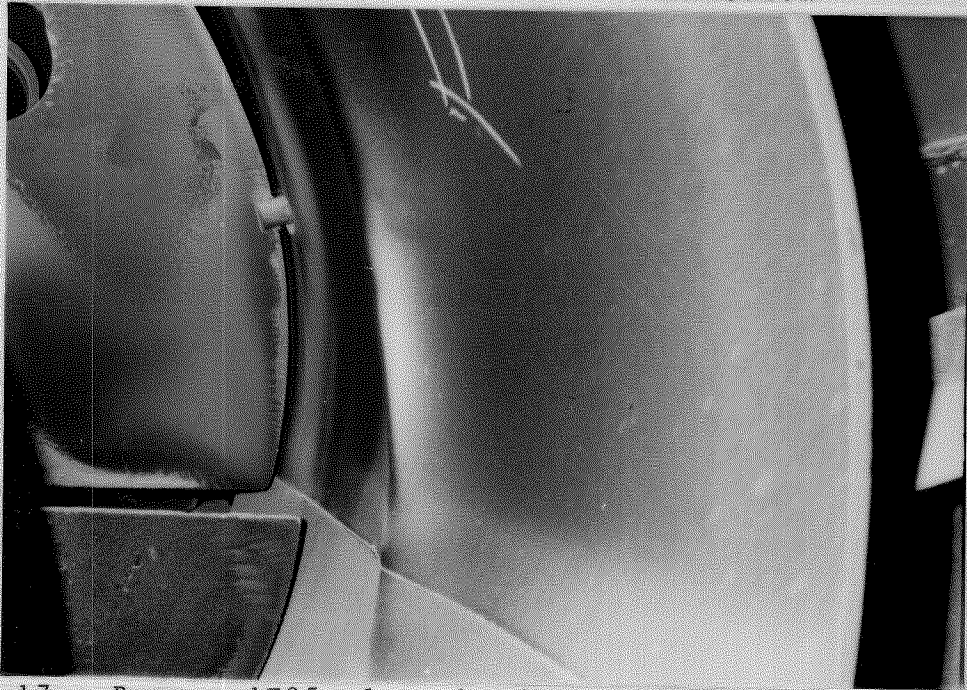
Photo 17 - Burner 1F05 also showing warping on outer portion of inner air sleeve as seen from furnace.

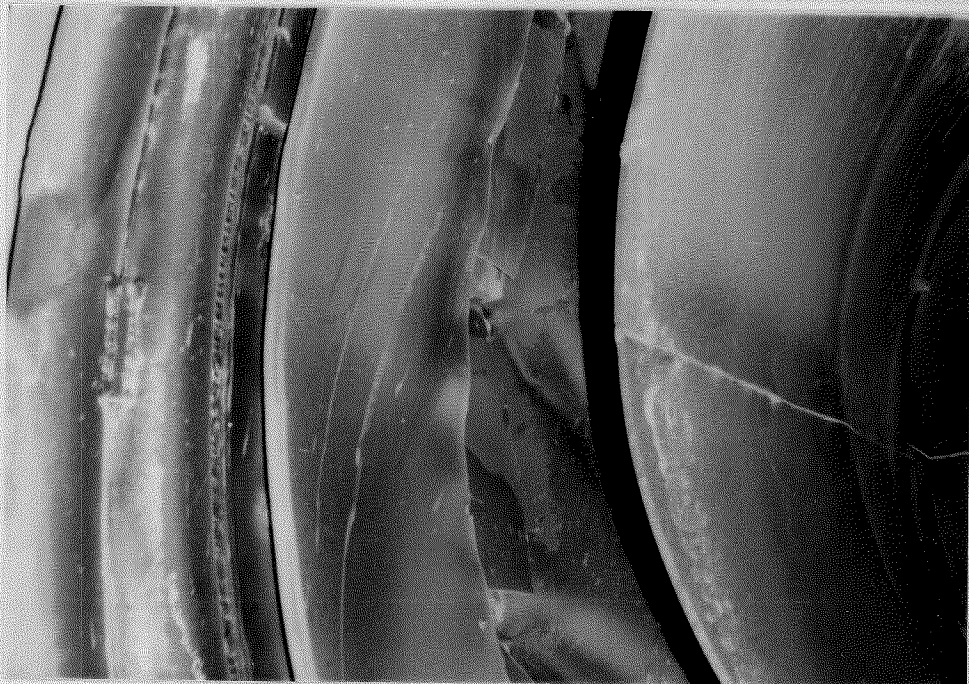
Photo 18 - Warping or rippling of throat sleeve casing ring.

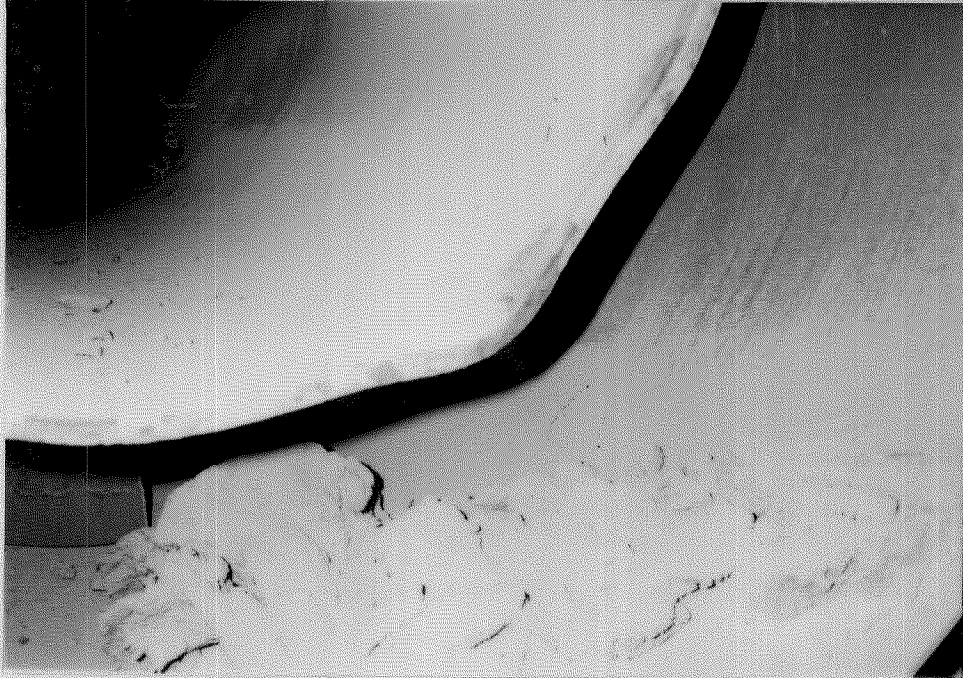
Photo 19 - Warping of a coal nozzle tip due to overheat conditions.

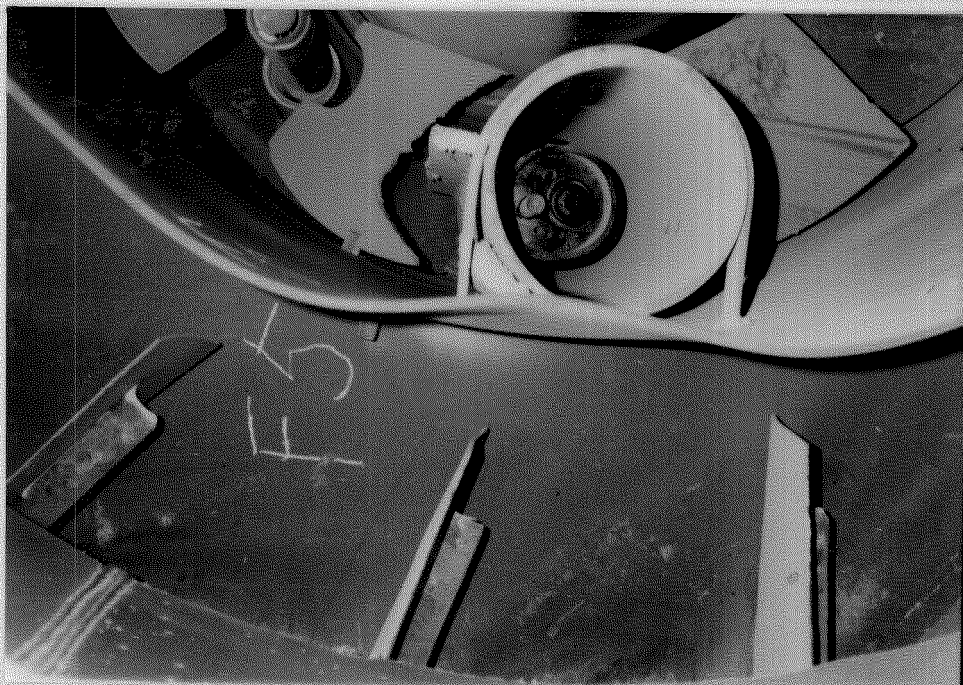
Photo 21 - Burner 1F05 inner air sleeve warpage at lighter shroud attachment due to overheating.

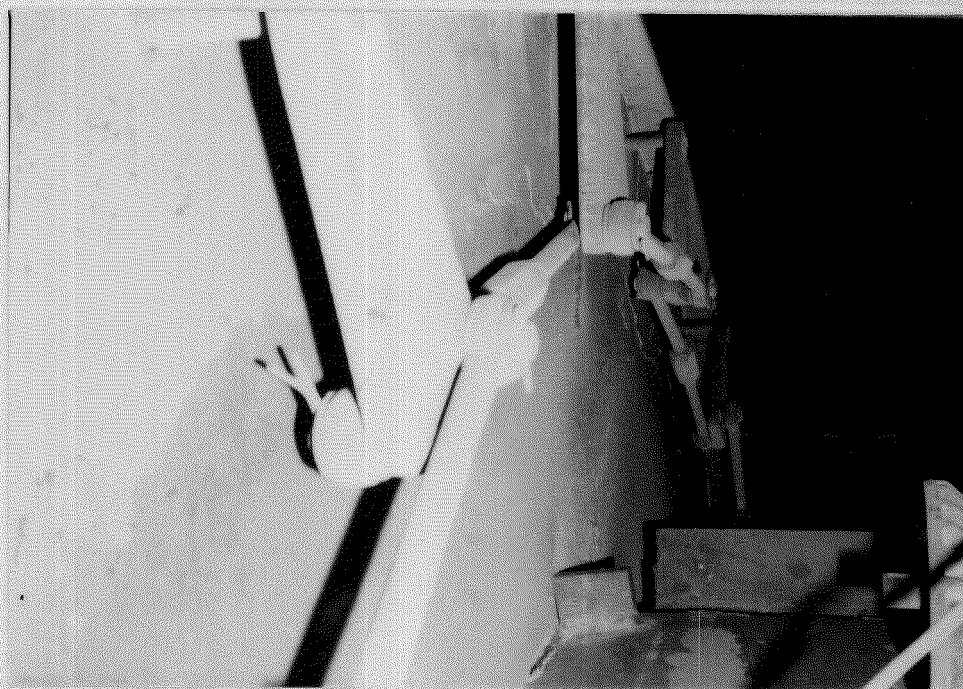
Photo 22 - Outer air register back (rear) plate with evidence of overheating shown by thermal expansion and discoloration.

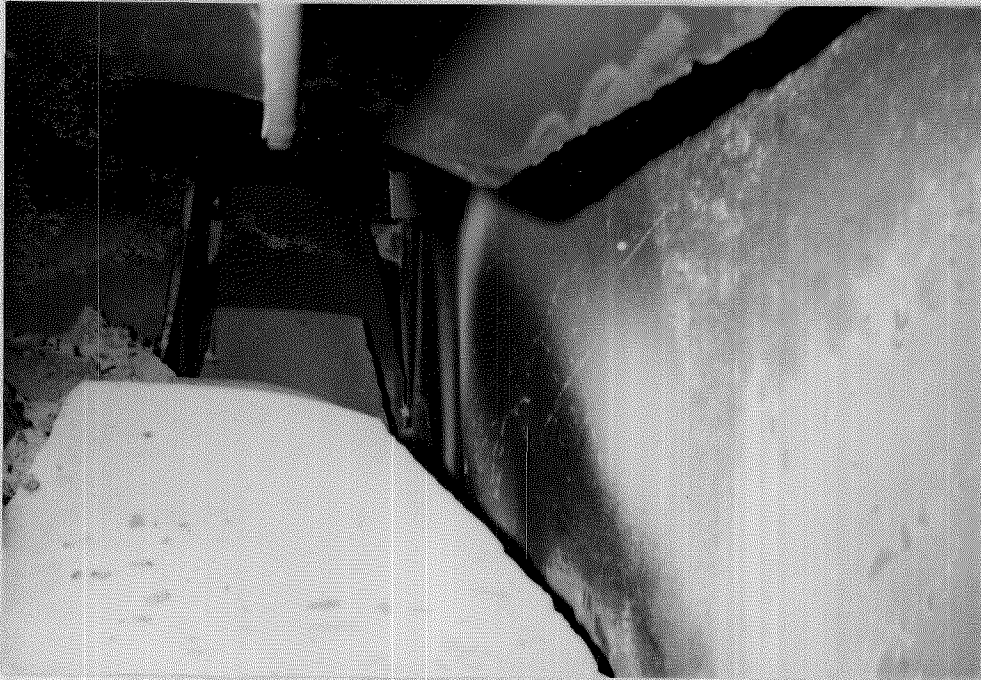
Photo 23 - Outer register front plate (from windbox) showing discoloration.

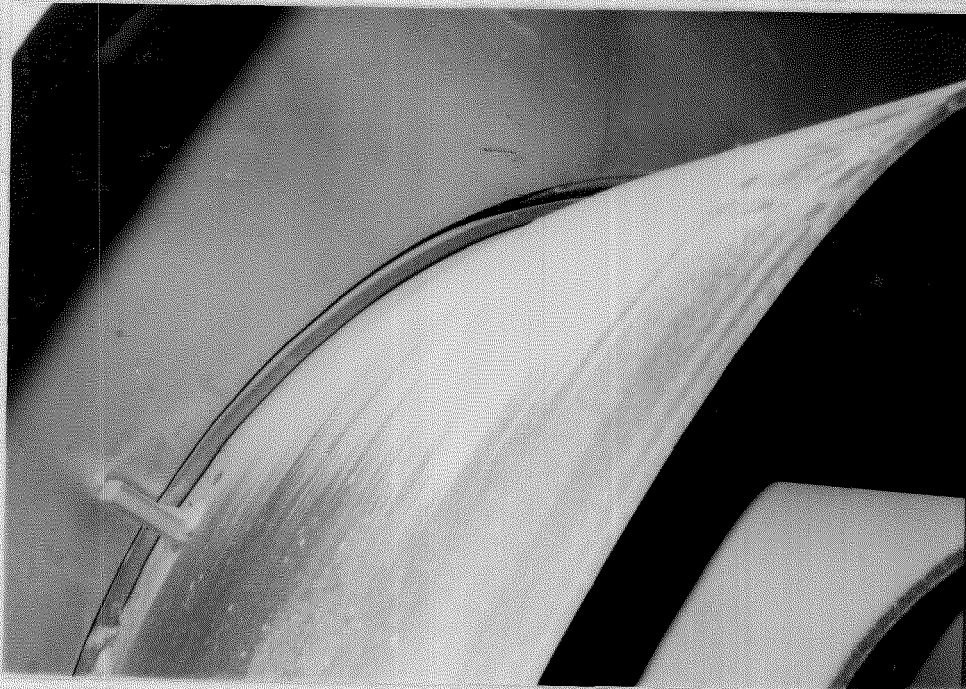
Photo 25 - Inner air sleeve barreling or bell-outing just beyond the outer air sleeve backplate.

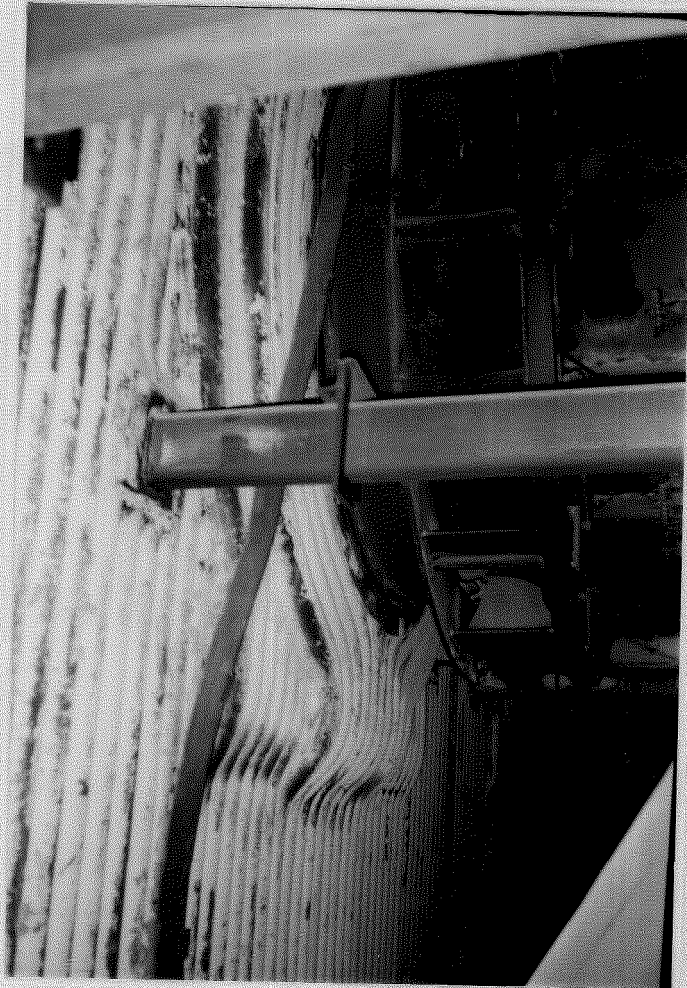
BURNER 1C04 CASING RING - During the windbox inspections, Burner 1C04 was found with the throat sleeve casing ring almost completely dropped out due to the attachment welds failing (reference Photos 27 through 29). This casing ring helps provide a seal for the outer air register assembly and throat sleeve to the waterwall front. The seal ring is intended to be packed with rope packing to provide an air tight seal. Maintenance reattached and repaired Burner 1C04's throat sleeve casing ring in its proper position (see Photo 30).

Photo 27 - Throat sleeve casing ring failure on Burner 1C04
due to broken welds and detachment.

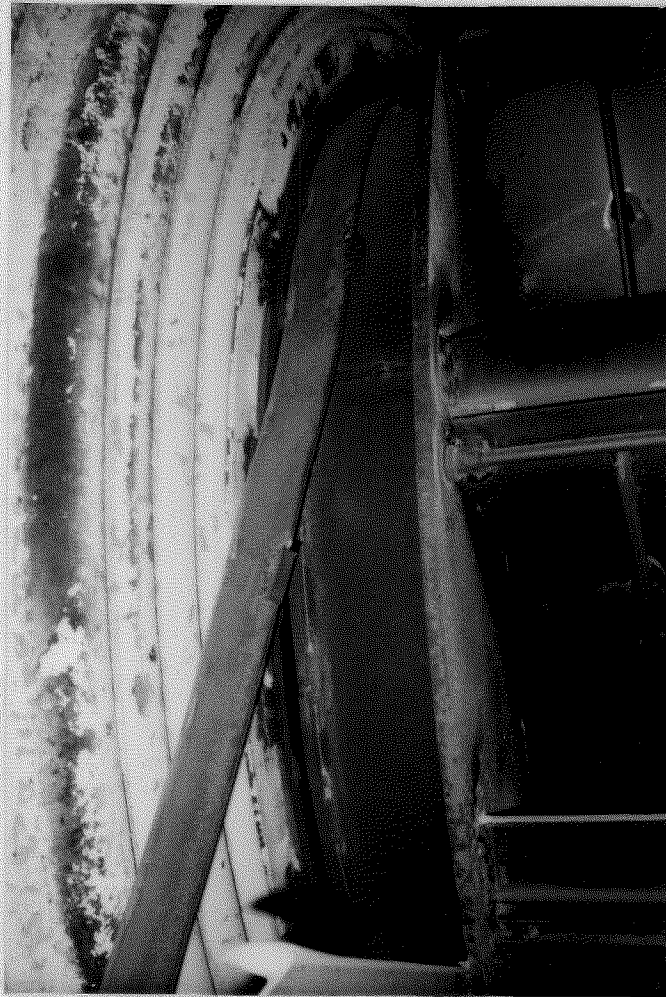
Photo 28 - Close-up of Burner 1C04 casing ring. Note one inch opening directly to furnace which allows air bypassing combustion zone.

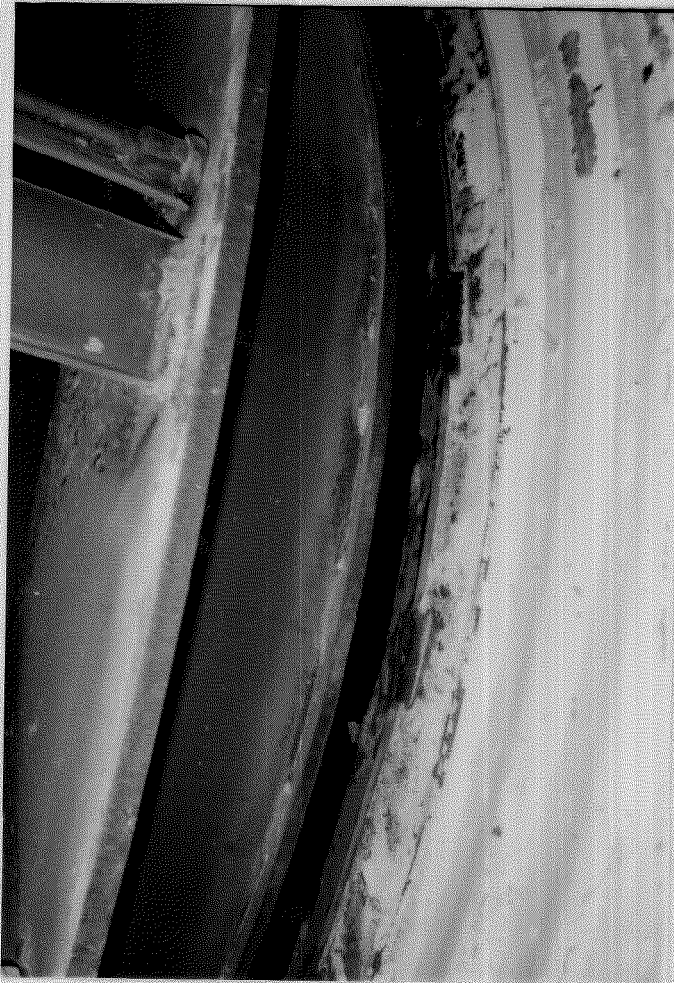
Photo 29 - Failed casing ring on Burner 1C04 showing open gap to furnace for combustion air leakage.

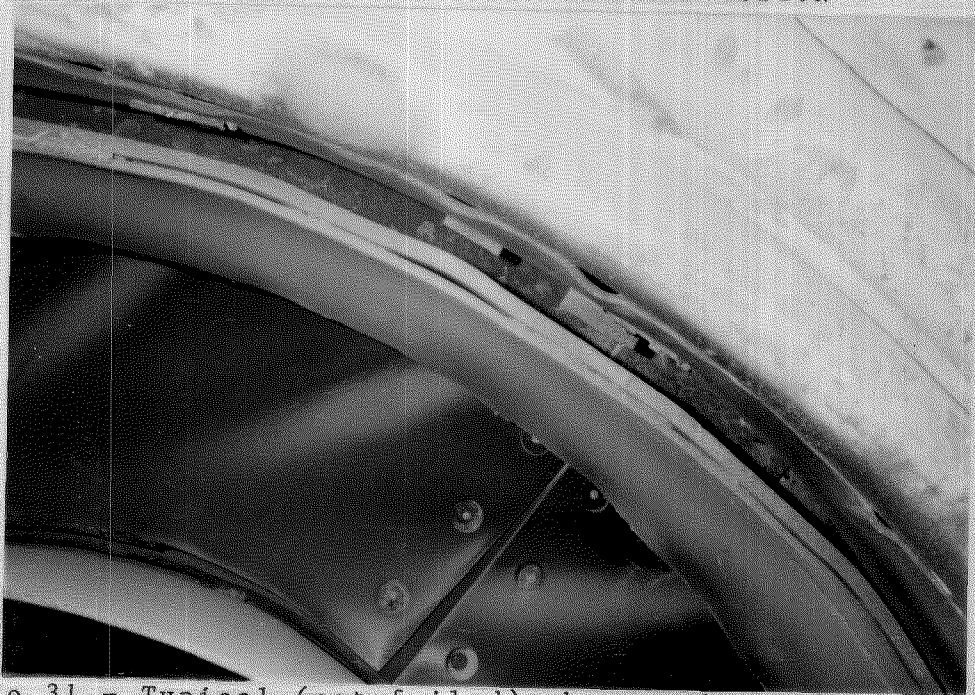
THROAT SLEEVE CASING RING SEAL - The throat sleeve casing ring which is to provide an air tight seal between the outer air register and the throat sleeve assembly to the waterwall is in a greatly deteriorated condition.

There are broken welds and warping of the casing ring which has caused excessive gaps to develop between the throat sleeve and waterwall. Roper packing which is to provide the air tight seal is 90% nonexistent.

This seal is to prevent air leakage from bypassing combustion (secondary) air flow from out around the outside of the burner. It also provides a seal to prevent fly ash, coal and fuel oil from being reentrained (licked-back) back into the windbox (reference Photos 31 and 44).

Photo 31 - Typical (not failed) throat sleeve casing ring, as shown from furnace side, showing deteriorated condition and gaps in the air tight seal.

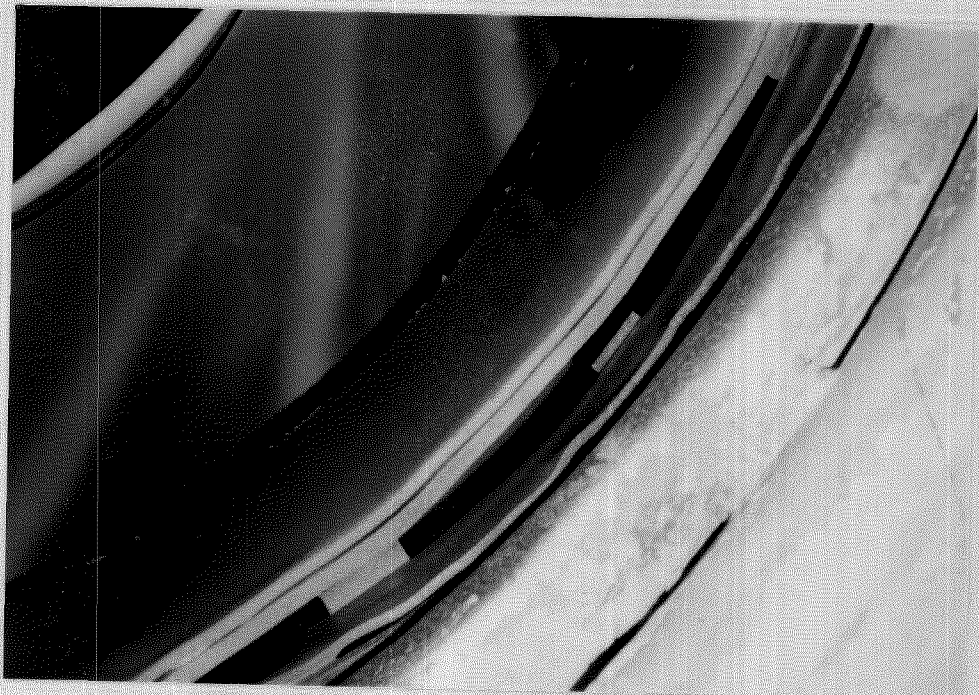
Photo 32 - Throat sleeve casing ring and seal showing signs of overheating and thermal expansion.

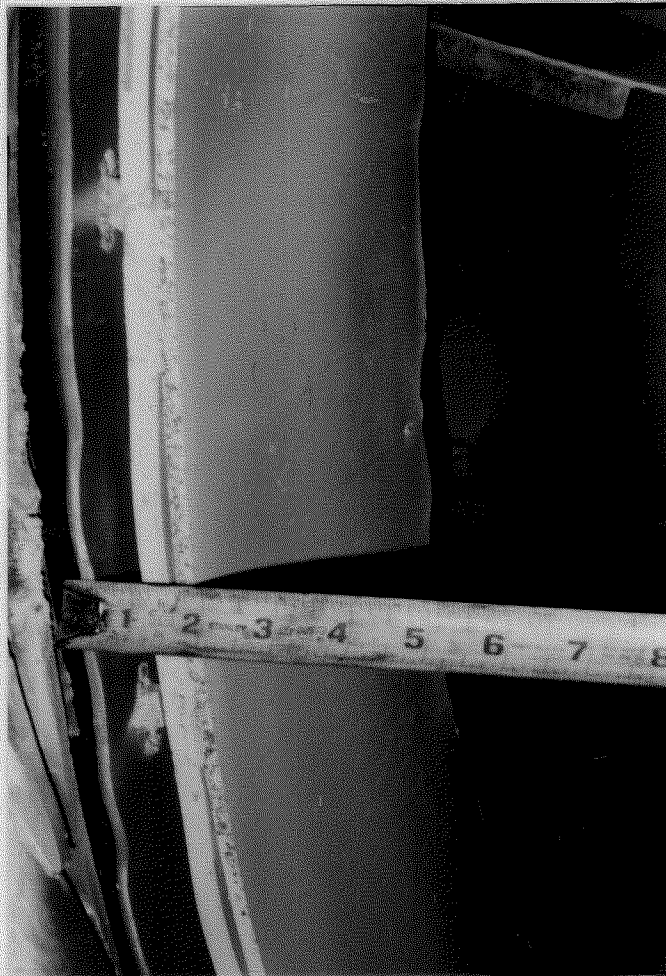
Photo 33 - Relative gap measurements on throat sleeve casing ring to waterwall showing the clearances which provide a major source for combustion air leakage.

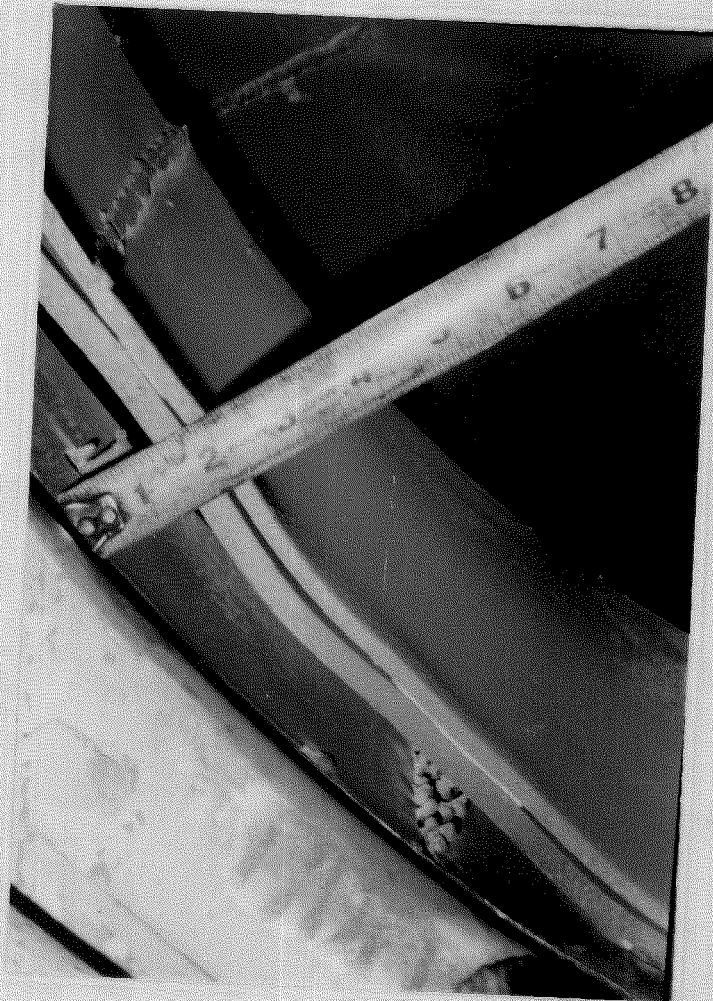
Photo 34 - Relative gap measurements on throat sleeve casing ring to waterwall showing the clearances which provide a major source of combustion air leakage.

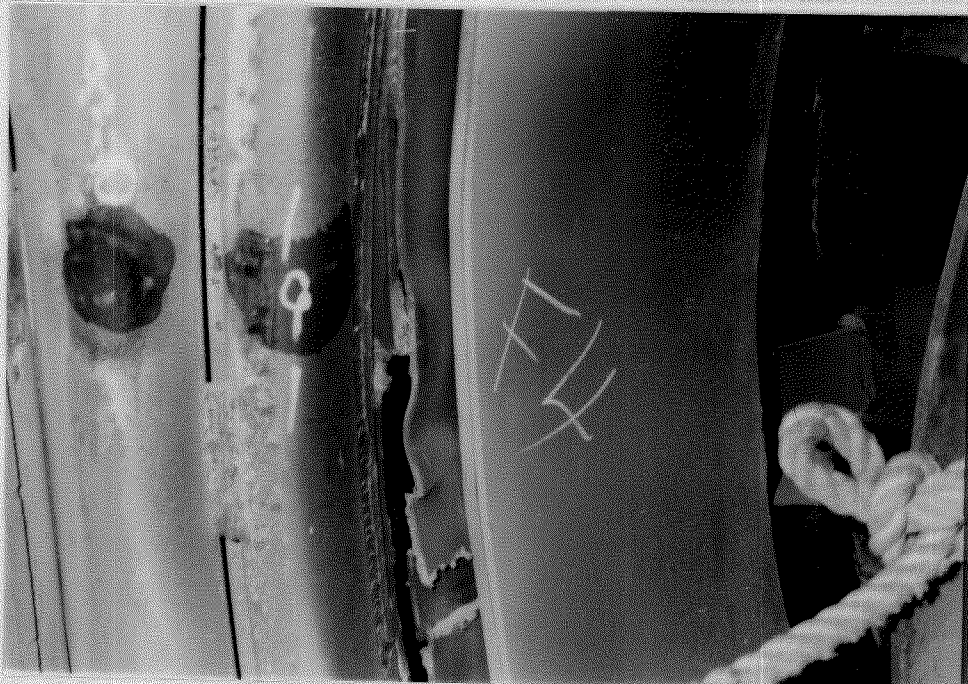
Photo 35 - Overheat and thermal growth cracks and tears on throat sleeve casing to waterwall front seal.

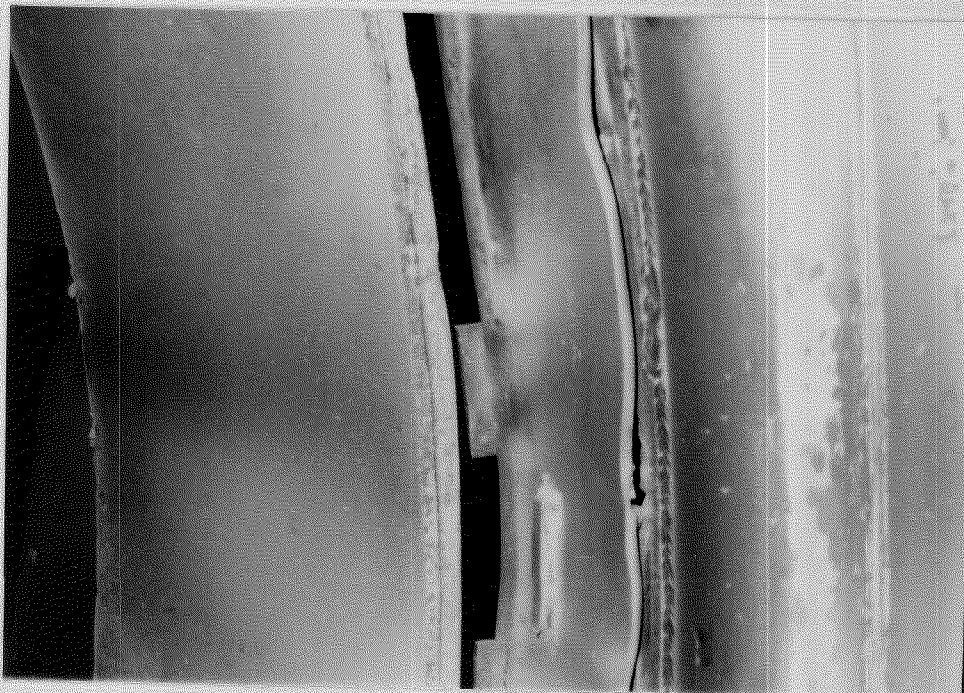
Photo 36 - Another view on a different burner of Photo 35.
